WL-TR-92-4040

DURABILITY OF ADHESIVELY BONDED STRUCTURE

**Al E. Hohman
Charles M. Standard
LTV Aerospace and Defense Company
Missiles Division
P.O. Box 650003
Dallas, Texas 75265-0003**

Final Report for Period April 1991 - March 1992

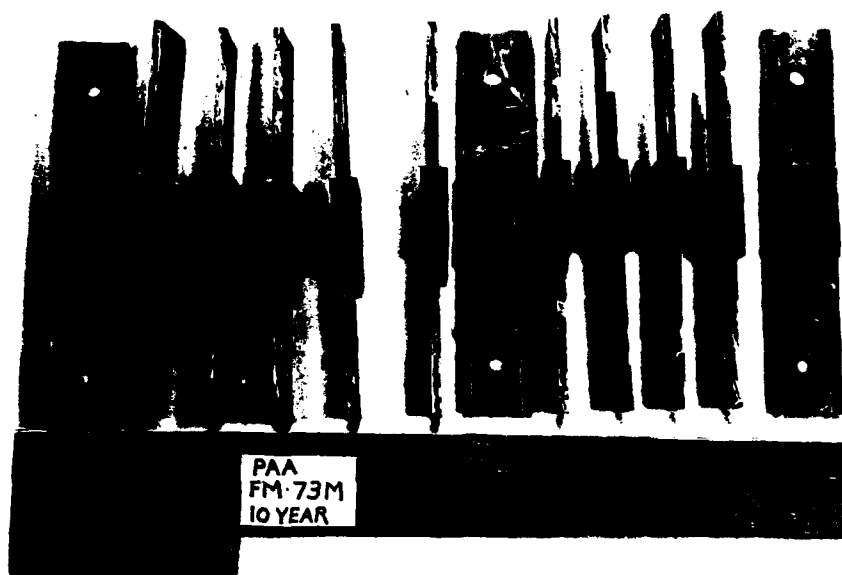
Figure 5: PAA/BR 127/FM 73M Specimens Stressed 800 psi and 1200 psi for 10 years

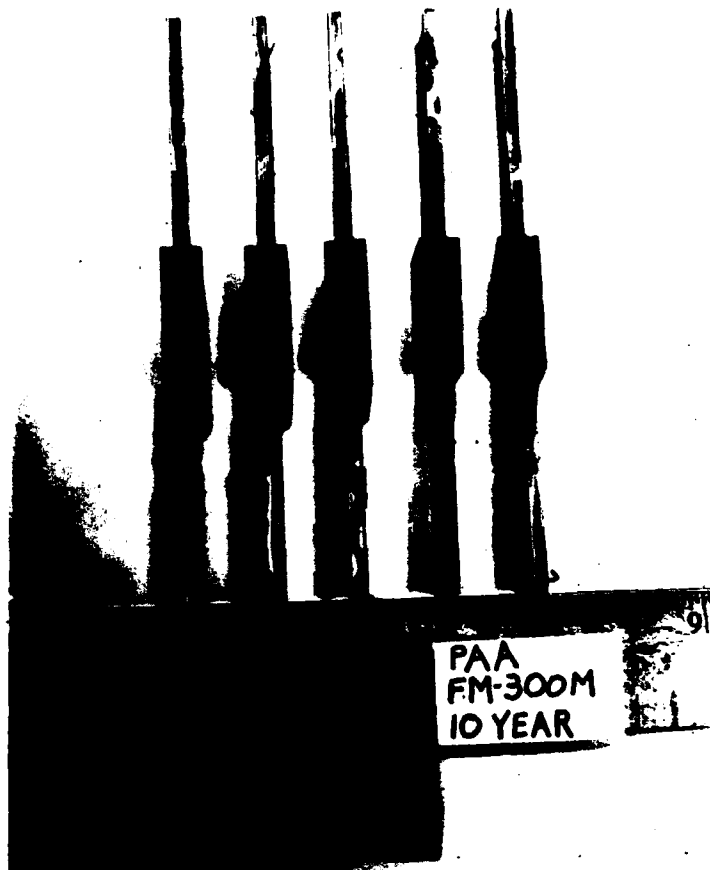
Figure 11: PAA/BR 127/FM 300M Specimens Exposed 10 years at 800 psi Nominal Stress

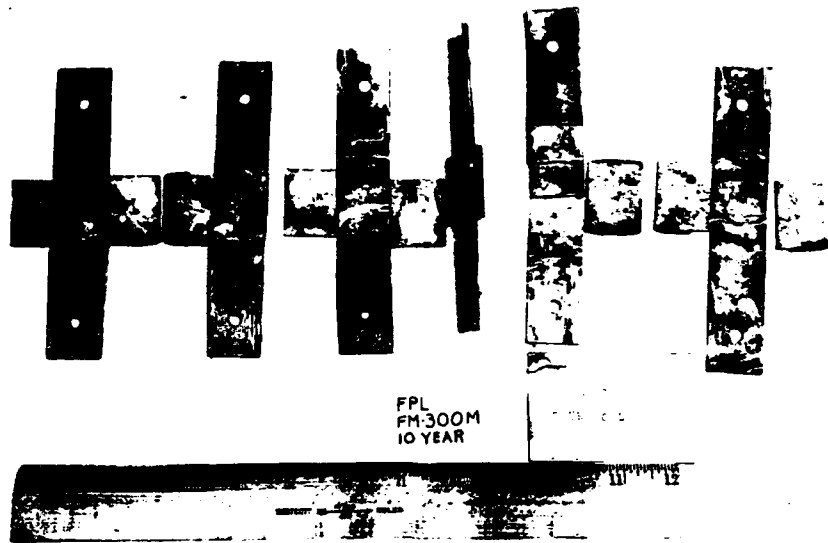
Figure 15: OFPL Specimens Delaminated During Removal from Rack

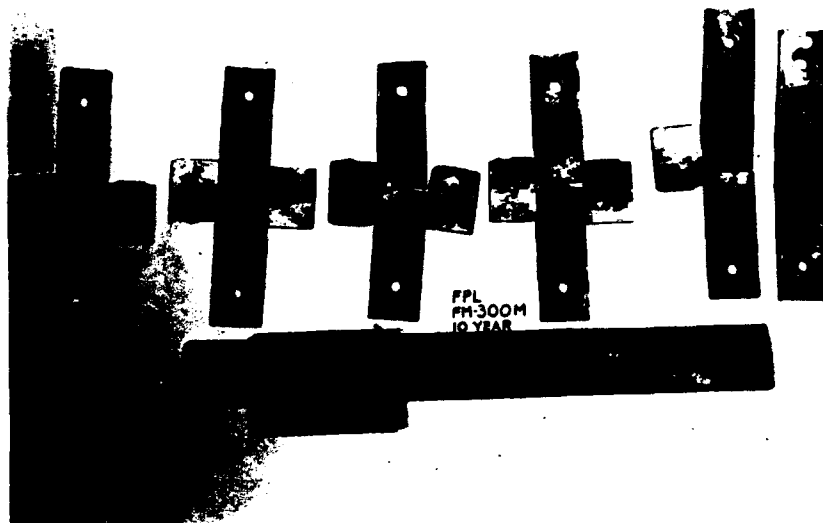
Figure 17: OFPL/BR 127/FM 300M Stressed at 1200 psi Nominal for 10 years
Delaminated During Removal from Rack

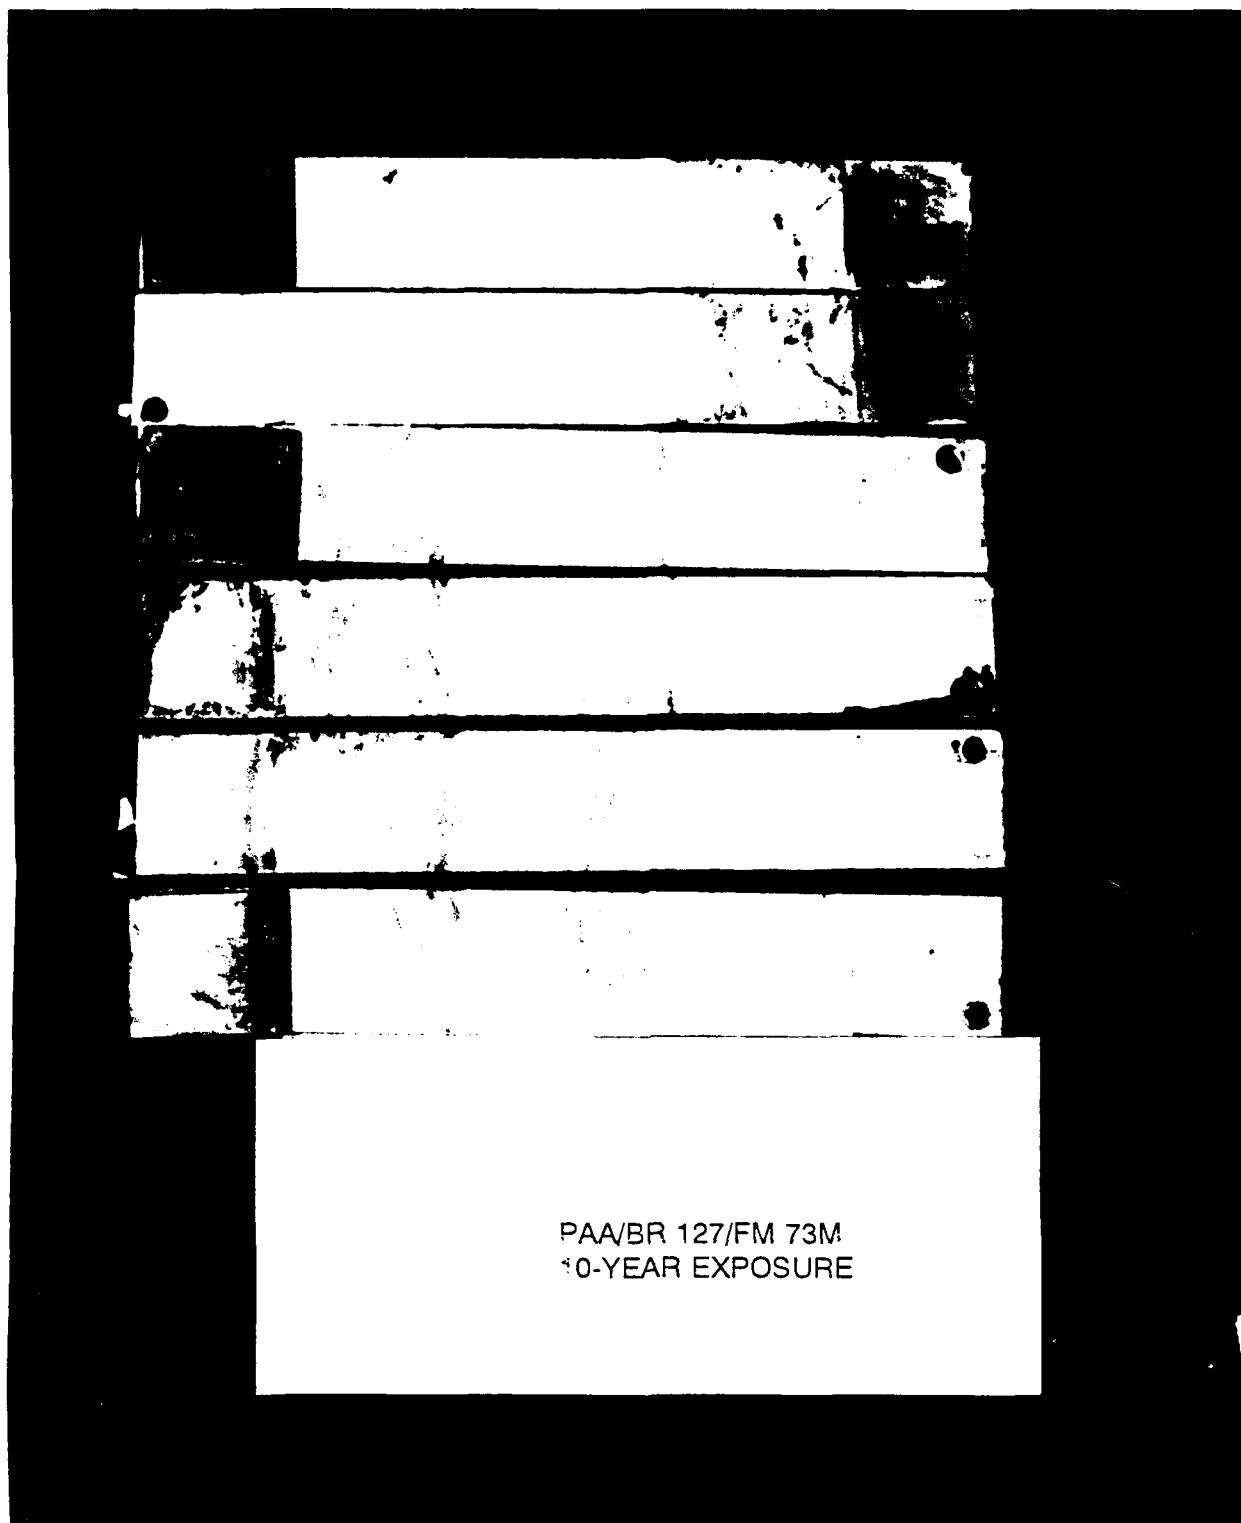
Figure 20: PAA/BR 127/FM 73M Crack Extension Specimens Exposed 10 years
in Marine Atmosphere

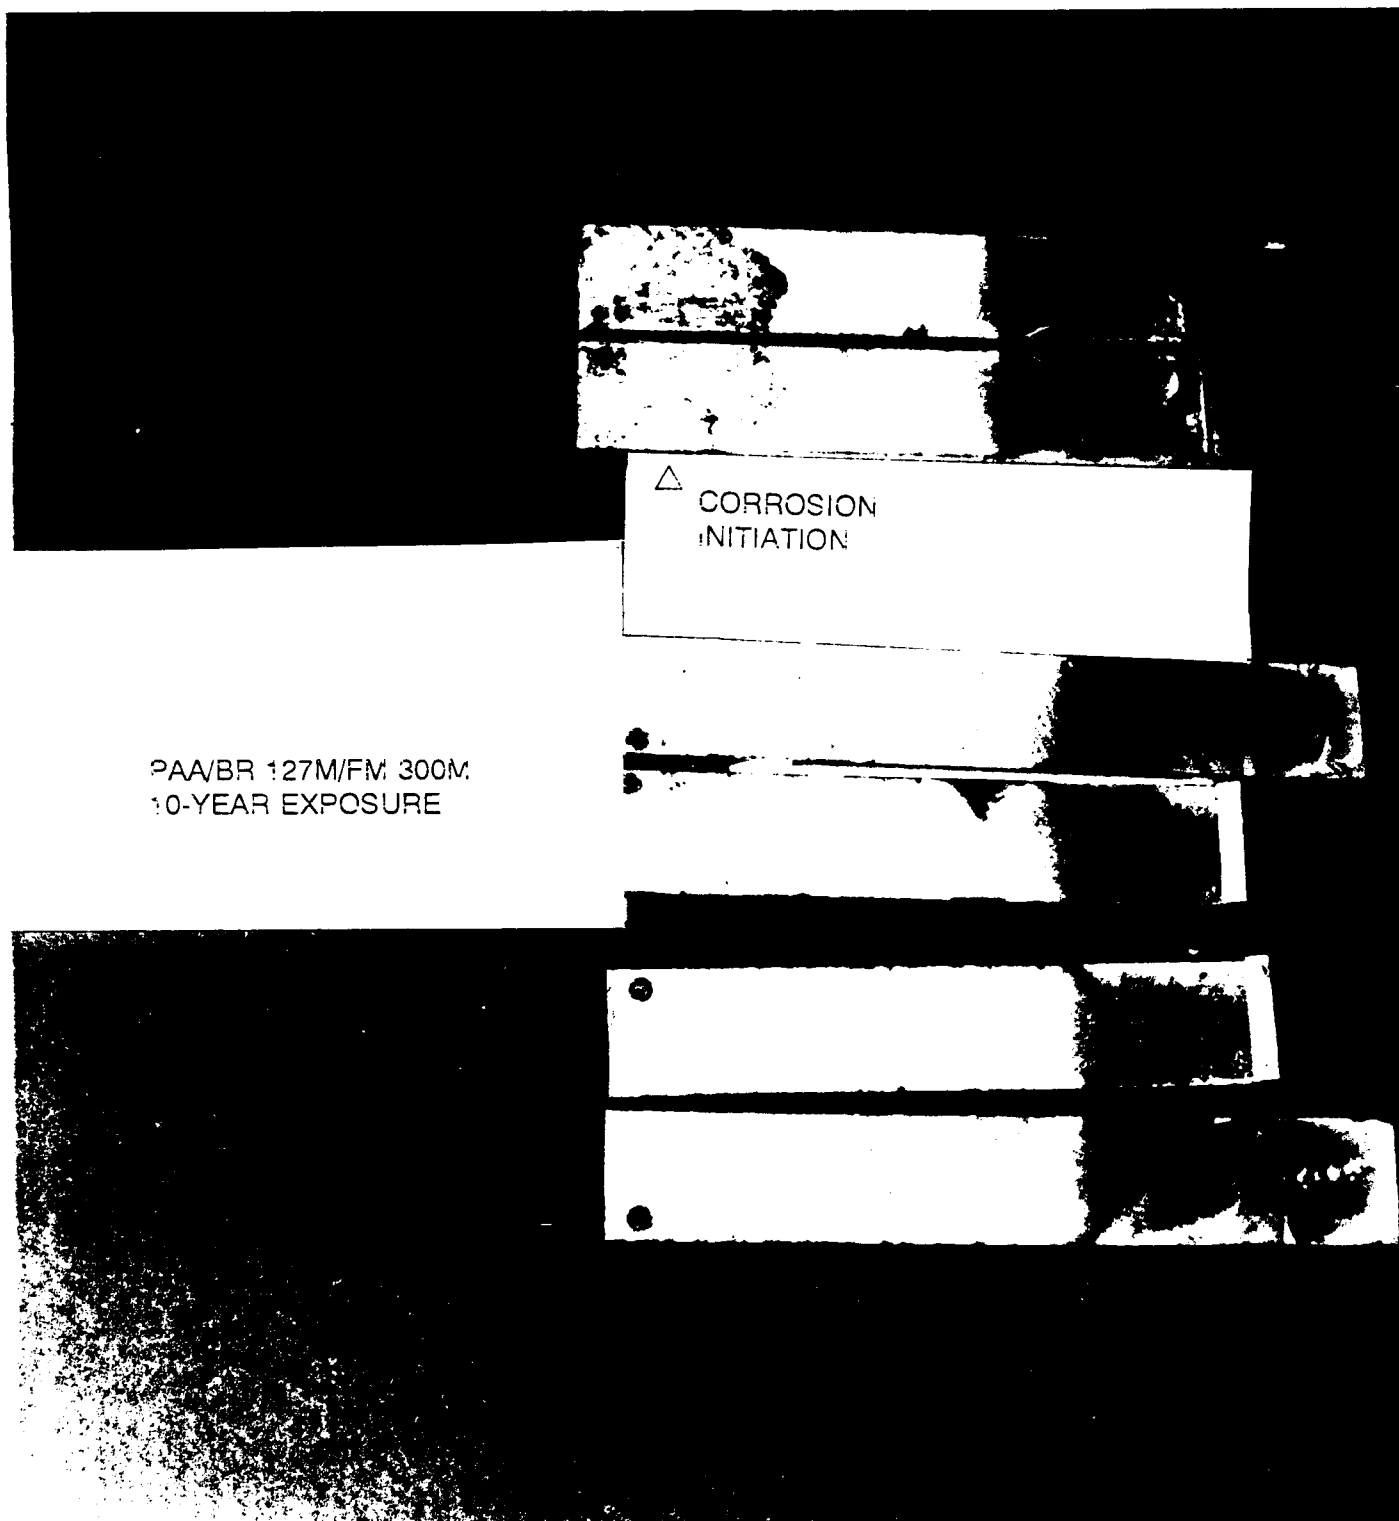
The mode of separation changes when corrosion becomes a factor. This is shown in Figure 24 where filiform has initiated bond line strength loss in the Phosphoric Acid Anodize, BR 127/ FM 300M crack extension specimens shown in Figure 2. Figure 25 shows most of the features which can be used to understand the filiform action in reducing the adhesion. An initiation site is seen at the notch which was used to mark the initial crack extension. This also provided an unprotected corrosion initiation site at the specimen edge. The dark area adjacent to the initiation site is a mature filiform. The shadow is filiform in a less developed condition to a point near the FM 300M adhesive edge. An aluminum hydroxide eruption is located slightly to the left of the V shape area of missing adhesive. This eruption is like the more translucent eruption adjacent to it and the eruption next to the smaller filiform initiation on the right hand upper portion of the figure. The adhesive has been lifted from this bond by

Figure 24: Crack Extension Specimens PAA/BR 127/FM 300M Showing Fillform:
initiations after 10 years Exposure
